# TO REPAIR, OR NOT TO REPAIR?

OUR RESIDENT EXPERT GUNSMITH HAS BEEN INUNDATED WITH QUESTIONS AND REQUESTS FOR STOCK REPAIRS AFTER HIS PREVIOUS ARTICLE, SO HERE HE GIVES US MORE EXAMPLES AND DETAILS OF HIS MIRACLE WORK

By Tim Greenwood

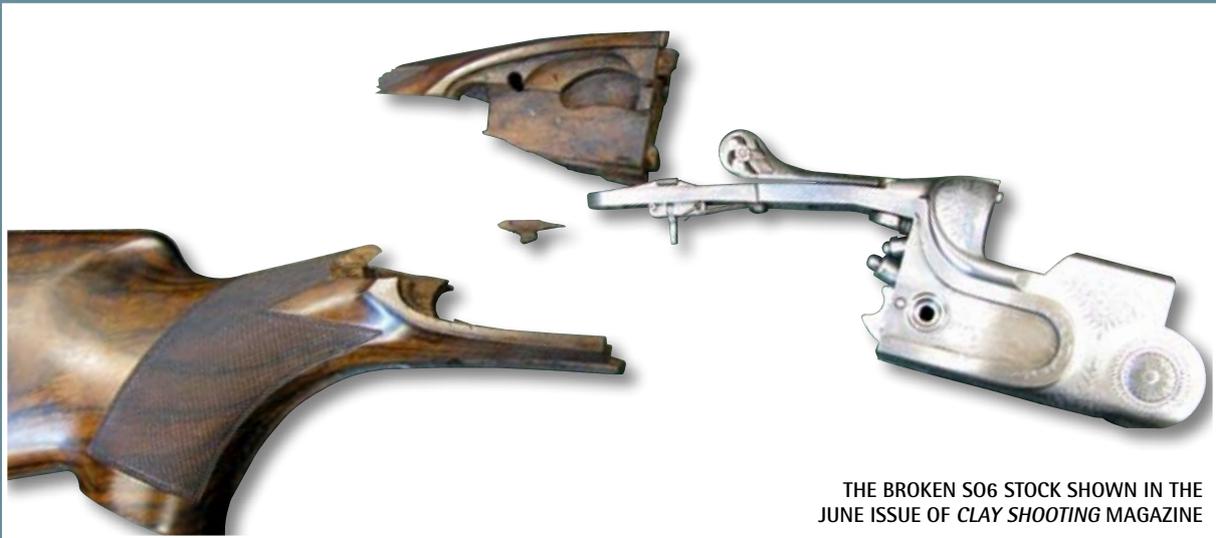
THE BROKEN SO6 STOCK SHOWN IN THE JUNE ISSUE OF CLAY SHOOTING MAGAZINE

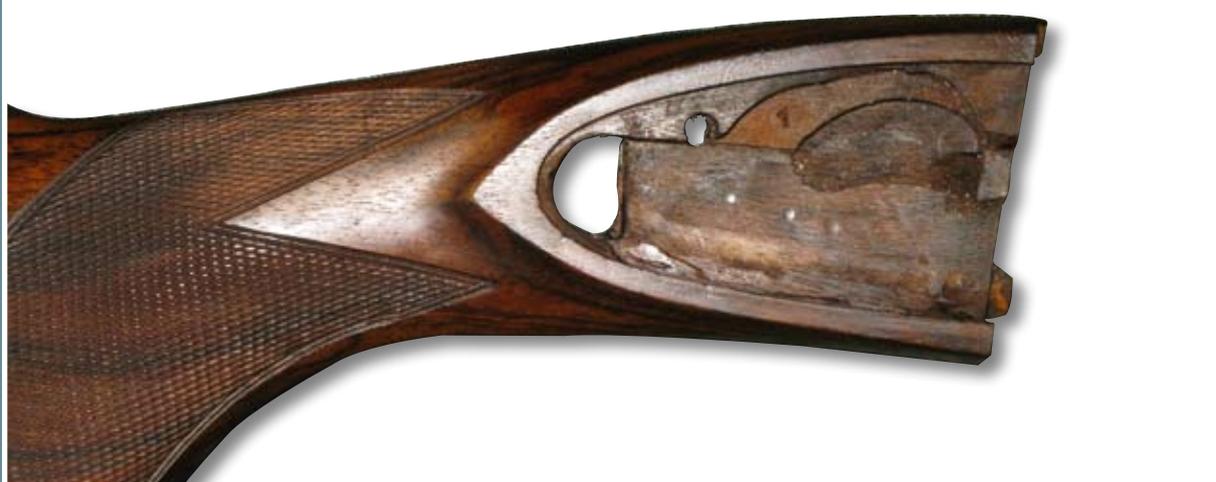
GOOD AS NEW – THE REPAIRED STOCK

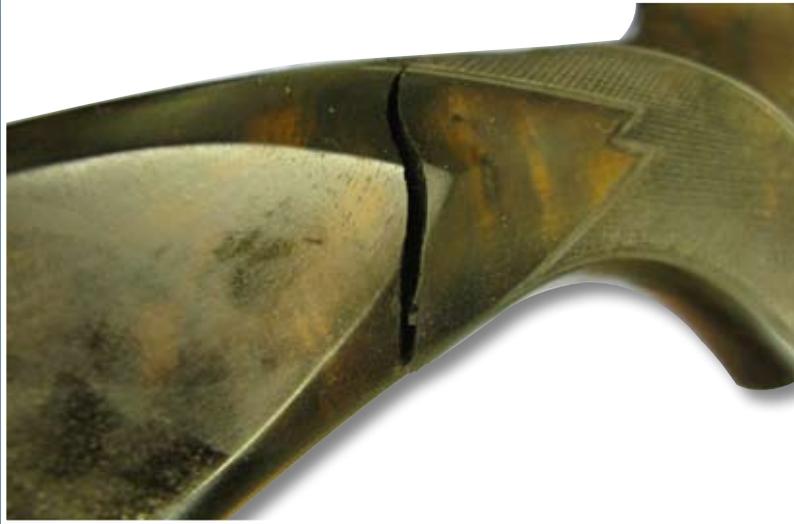
The damaged stock in this picture and the one below belong to a Browning 525 o/u 12b. Apart from the head of the stock being full up with action oil, which softens the timber, the main damage has been caused by someone casting the stock to left hand without relieving the head or the draw bolt hole. This major crack is the result.

**A REALLY BAD BREAK CAUSED BY POOR STOCK CASTING TECHNIQUE. NOTICE THE OIL OOZING FROM THE WOOD DUE TO OVER-OILING AND THE GUN BEING STORED STOCK DOWN**

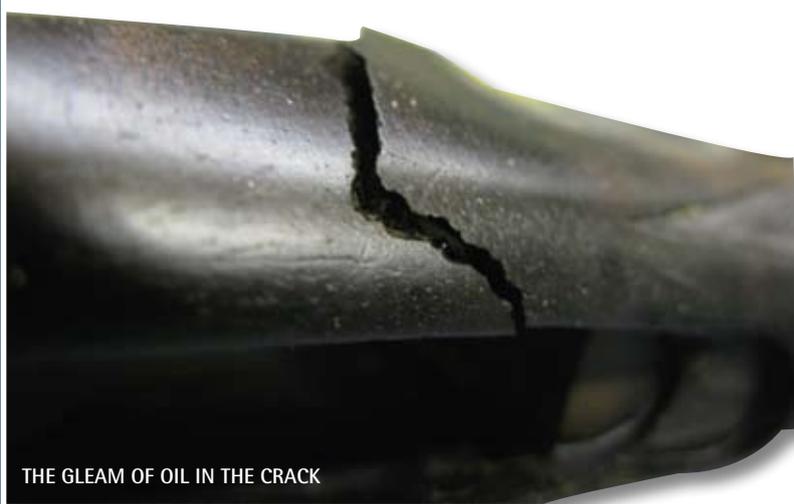
THE GLEAM OF OIL IN THE CRACK

If you look carefully you can see how open the grain is in the head of the stock, and the glisten of the mineral oil in the crack. Before attempting the repair it is essential to extract as much of this oil from the stock as possible.

There are many ways of doing this but my favourite is to either wrap the head in kitchen roll and put it in the airing cupboard, or to gently steam the area, wiping off the oil as it bleeds from the wood, then leave to dry.

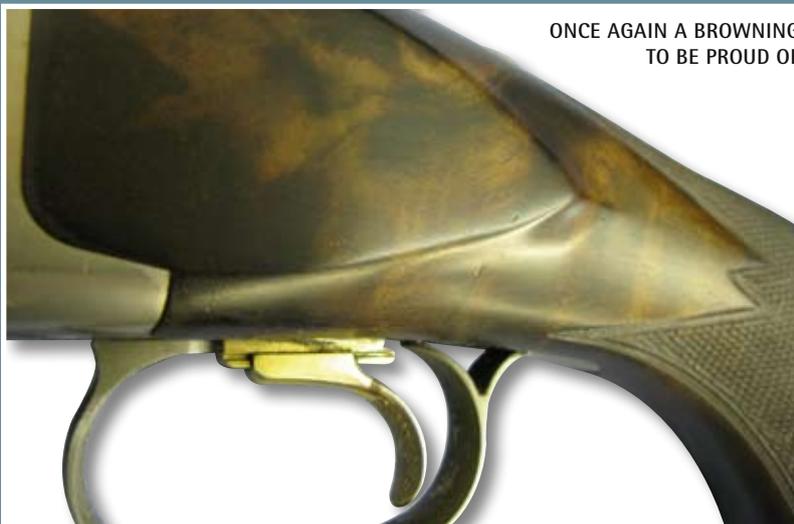
ONCE AGAIN A BROWNING TO BE PROUD OF

Once the crack and head are as free from oil as possible, industrial strength Cyanoacrylate glue is injected into the crack; the stock is then bolted back onto the action (applying a suitable releasing agent to the action first) then clamped to set overnight.

After releasing the stock from the action any excess glue is removed; the area is rubbed down, being careful not to change the profile. This picture shows the result after re-finishing.

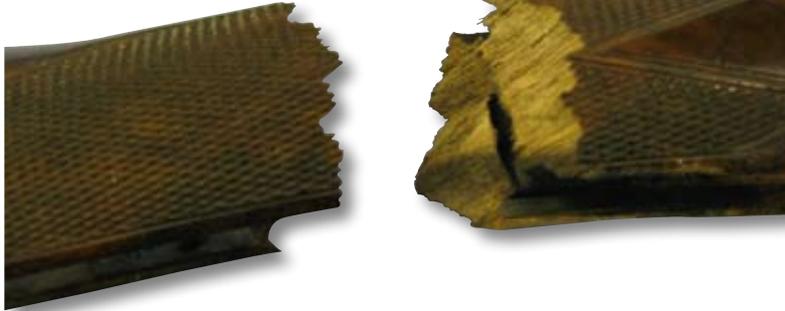
**THE BROKEN HAND OF A CLASSIC ENGLISH BOXLOCK**

The next repair, however, was a lot harder to undertake. This picture shows a rather expensive English boxlock, with the stock snapped through the hand.

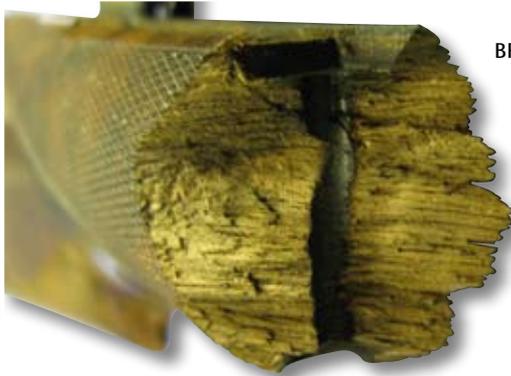
**THE CROSS-SECTION OF THE BREAK. LOOK HOW FIBROUS THE GRAIN IS AND THE DIRECTION ACROSS THE GRIP**

It is interesting to see, under closer examination, that the grain through the break is very dry, open and running the wrong way to give maximum strength through the thinnest part of the stock. It is always ideal for the grain at this point to run from the stock head (the action end) towards the butt. It is lovely to see highly figured wavy grain in a stock, but not through the grip. There is an old saying in stocking – “straight is strong”.

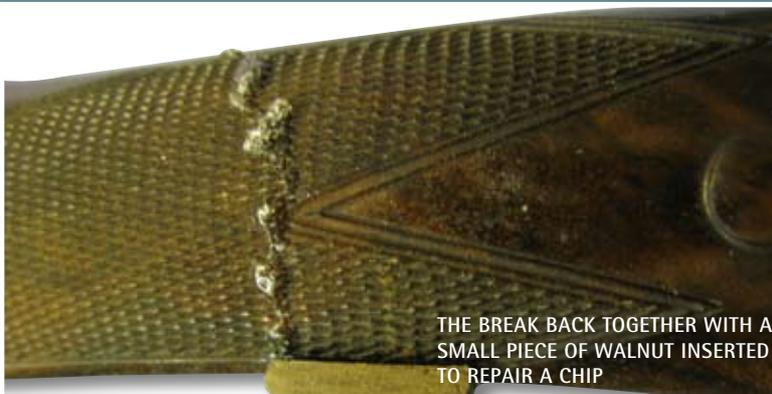
**THE BREAK BACK TOGETHER WITH A SMALL PIECE OF WALNUT INSERTED TO REPAIR A CHIP**

The first part of the repair, as shown here, was to fit the two halves back together in as near perfect alignment as possible, using, once again, Cyanoacrylate.

I also took the opportunity to fit small pieces of walnut into the chipped areas around the break. Once again, if the the wood is full of mineral oil it is essential to remove as much as possible to ensure a good repair

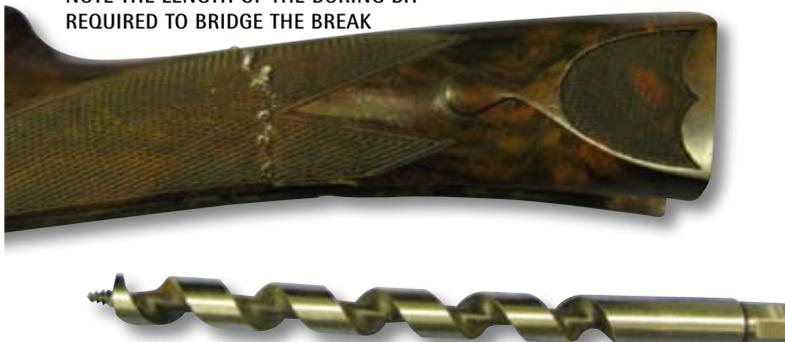
**NOTE THE LENGTH OF THE BORING BIT REQUIRED TO BRIDGE THE BREAK**

However, due to the small surface area, and the weakness in the grain, a simple glue repair would not do. The next stage was to bore a hole from the head of the stock, down through the action inletting and through the grip to bridge the break. This whole operation has to be carried out slowly by hand so you can feel the response of the stock. A great deal of care is needed to not break open the crack repair or cause more damage.

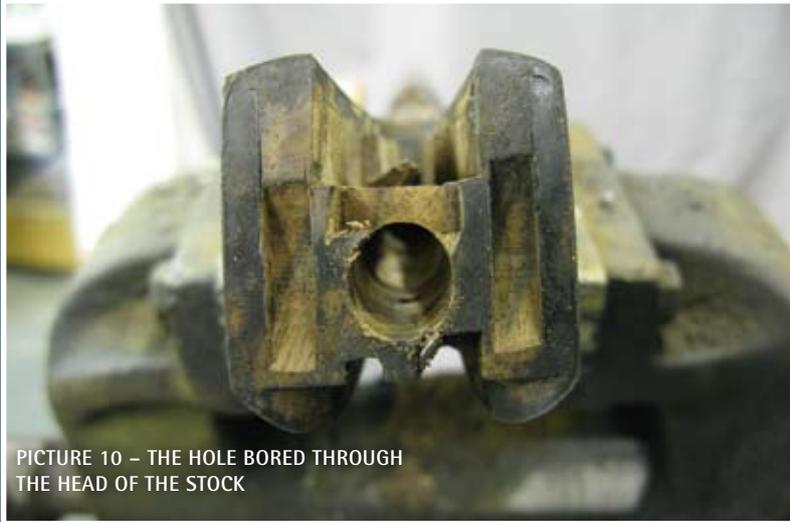
PICTURE 10 – THE HOLE BORED THROUGH THE HEAD OF THE STOCK

I have to confess, this is the part of the repair operation that I find most nerve-racking. It is always with a sense of relief to see a nice, straight bore hole when the auger drill bit is removed. You can feel the grip flexing as the bit cuts into the wood at this point. A little too much pressure to the cutter can destroy the head, splintering the inletting and destroying the wood to metal fit when the gun is re-assembled, or worse still, you could cause a longitudinal crack from the head down through the grip, weakening the whole repair.

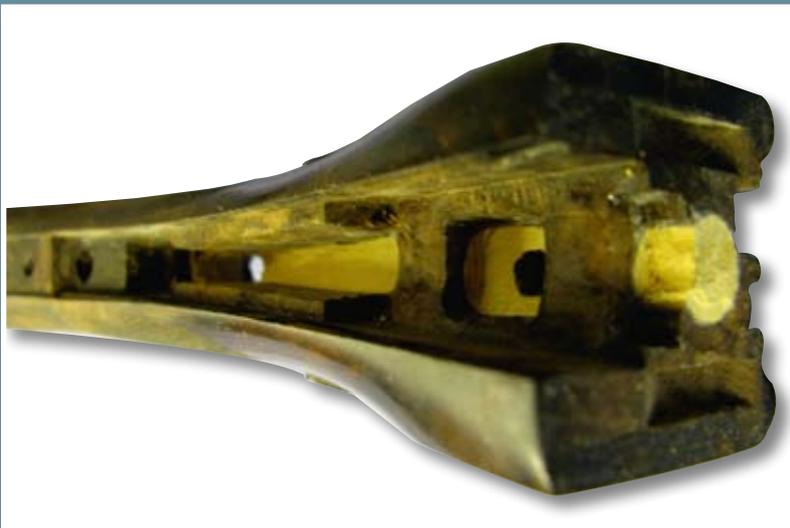
THE DOWEL INSERTED AND HEADED UP FOR THE ACTION

Once the hole has been bored a 15mm hardwood dowel, usually beech, is inserted into the hole and bonded in place with a two pack industrial resin, therefore bridging the break and adding considerable strength through the grip.

Finally, in this part of the operation, the head has to be re-inletted to accept the action, as shown in this picture

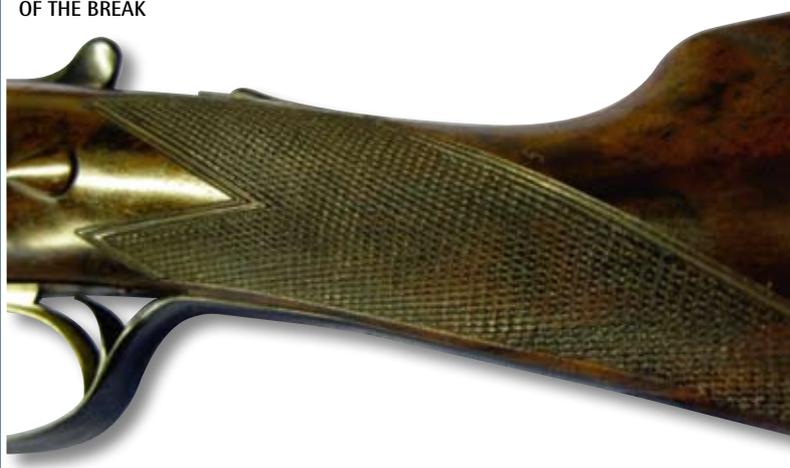
ALL FINISHED AND NOT A SIGN OF THE BREAK

After re-assembling the gun to check that the inletting was correct and the action functioned correctly, the stock was once again taken off the action for finishing. The excess glue had to be removed and the replacement wood fitted to the chipped areas had to be shaped by rasp then sanding.

Finally, the chequering had to be picked up and reproduced over the damaged area. As you can see, with a little colour matching and re-finishing, the repair is nearly impossible to see and, due to the hidden dowel, very strong.
